UNITED STATES ENVIRONMENTAL PROTECTION AGENCY

SUBJ: RCRA Compliance Evaluation Inspection
Chemical Waste Management
EPA ID# ALD000622464

On November 17-20, 2015, a U.S. Environmental Protection Agency Compliance Evaluation Inspection was conducted at Chemical Waste Management in Emelle, Alabama, to determine the facility's compliance status with the Resource Conservation and Recovery Act (RCRA).

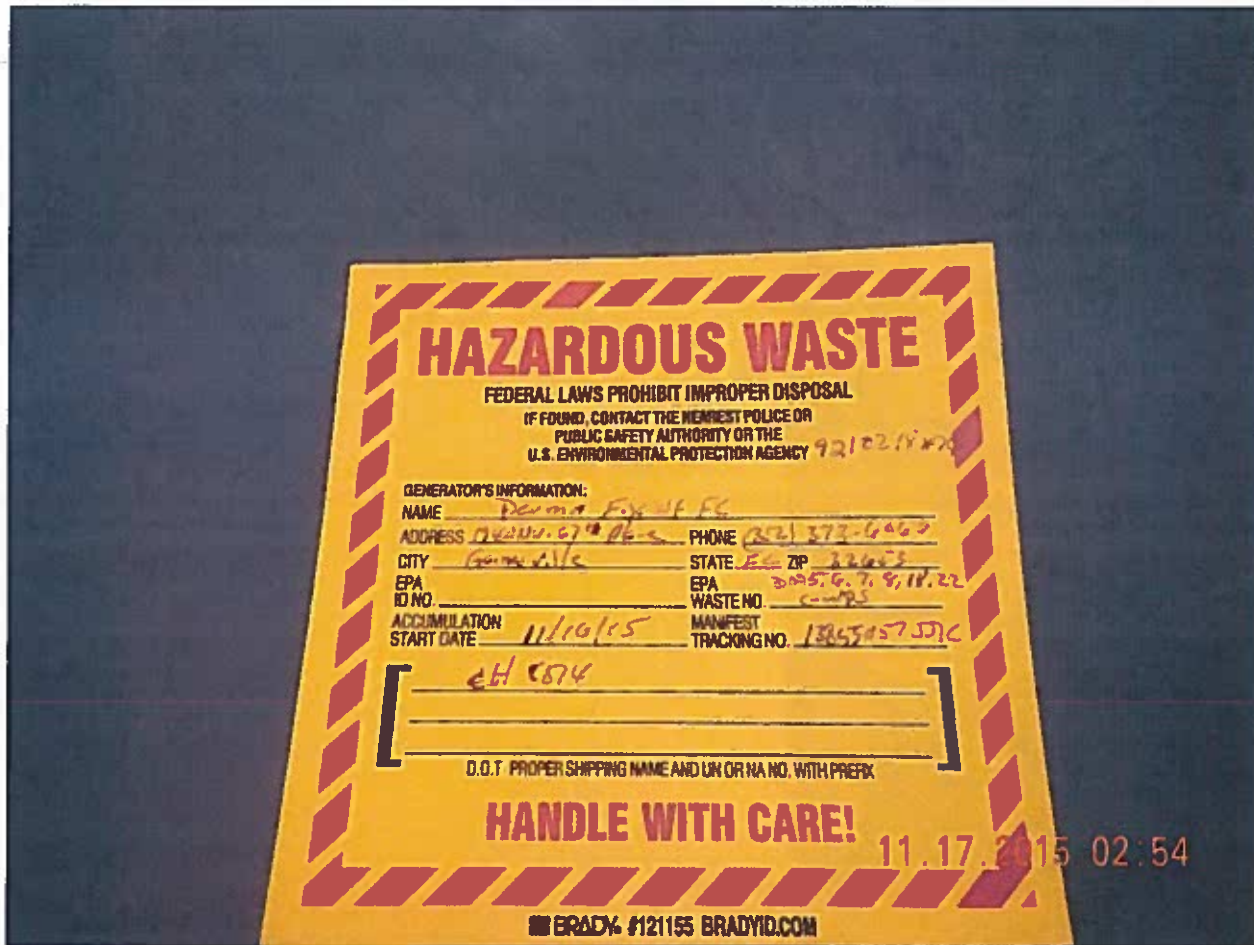
PHOTO #6

During this portion of the inspection, the inspectors first observed a collection of approximately 50 unburied macroencapsulation vaults (see Photo #6) within the coordinates of O-P and 11-12, level five (5). Mr. Sturdivant explained that each macroencapsulation vault could contain waste from different clients/generators. The vaults are manufactured by Waste Management and made of high-density polyethylene (HDPE), with the capacity to hold 20 cubic yards of waste. Each vault was sealed and had a hazardous waste label identifying the original container #, generator information, EPA waste #, date of receipt, profile # in AS400, and manifest tracking # (see Photo #7). The inspectors selected the macroencapsulation vault containing wastes from Manifest # 013859918JJK to later cross-reference against the facility’s burial logs. During records review, Ms. Linda Knickerbocker was able to verify that the facility’s burial records did in fact coincide with the burial coordinates observed by the inspectors during their inspection of the active cell (see Attachment J).

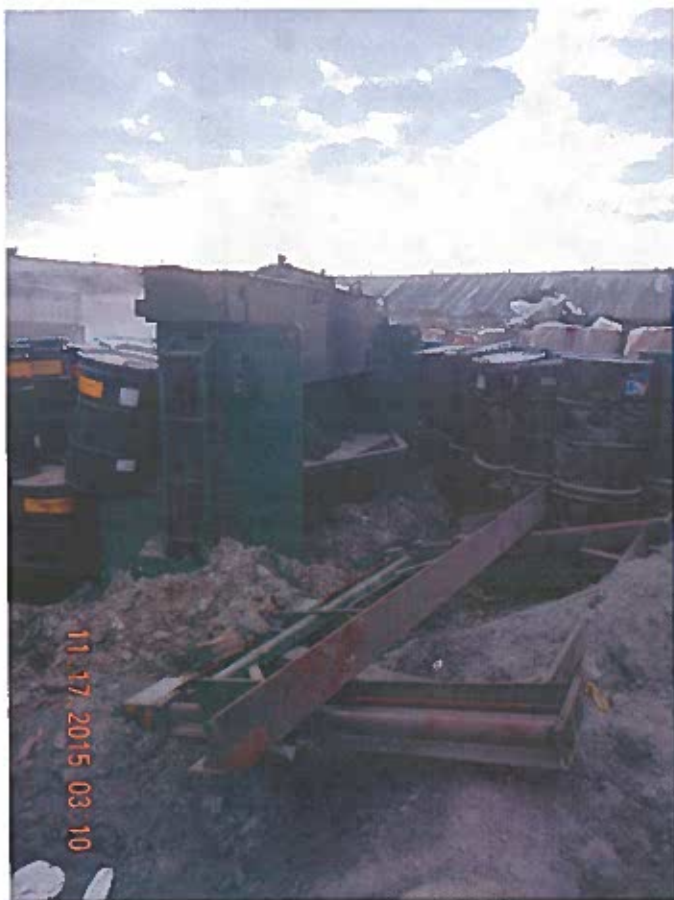
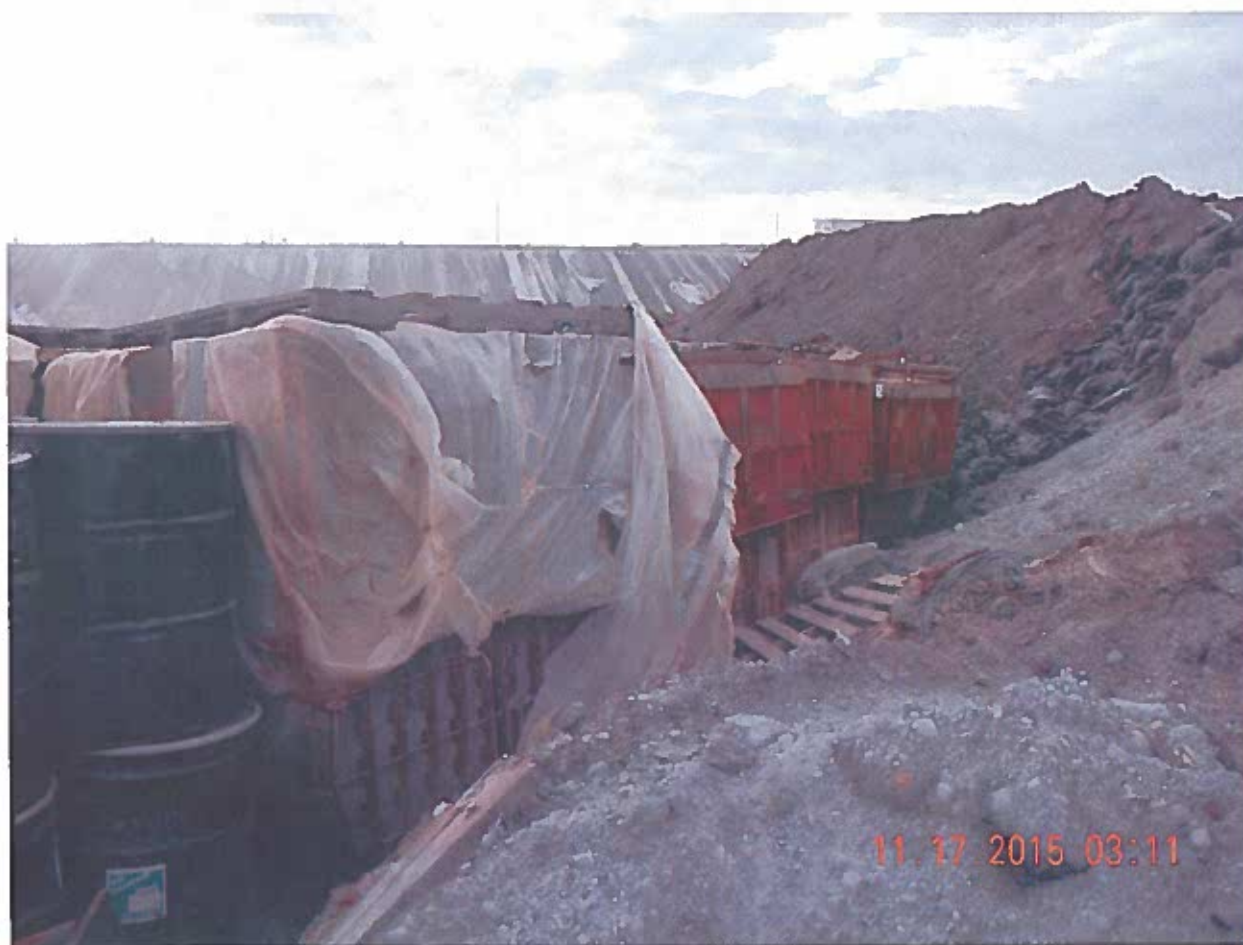
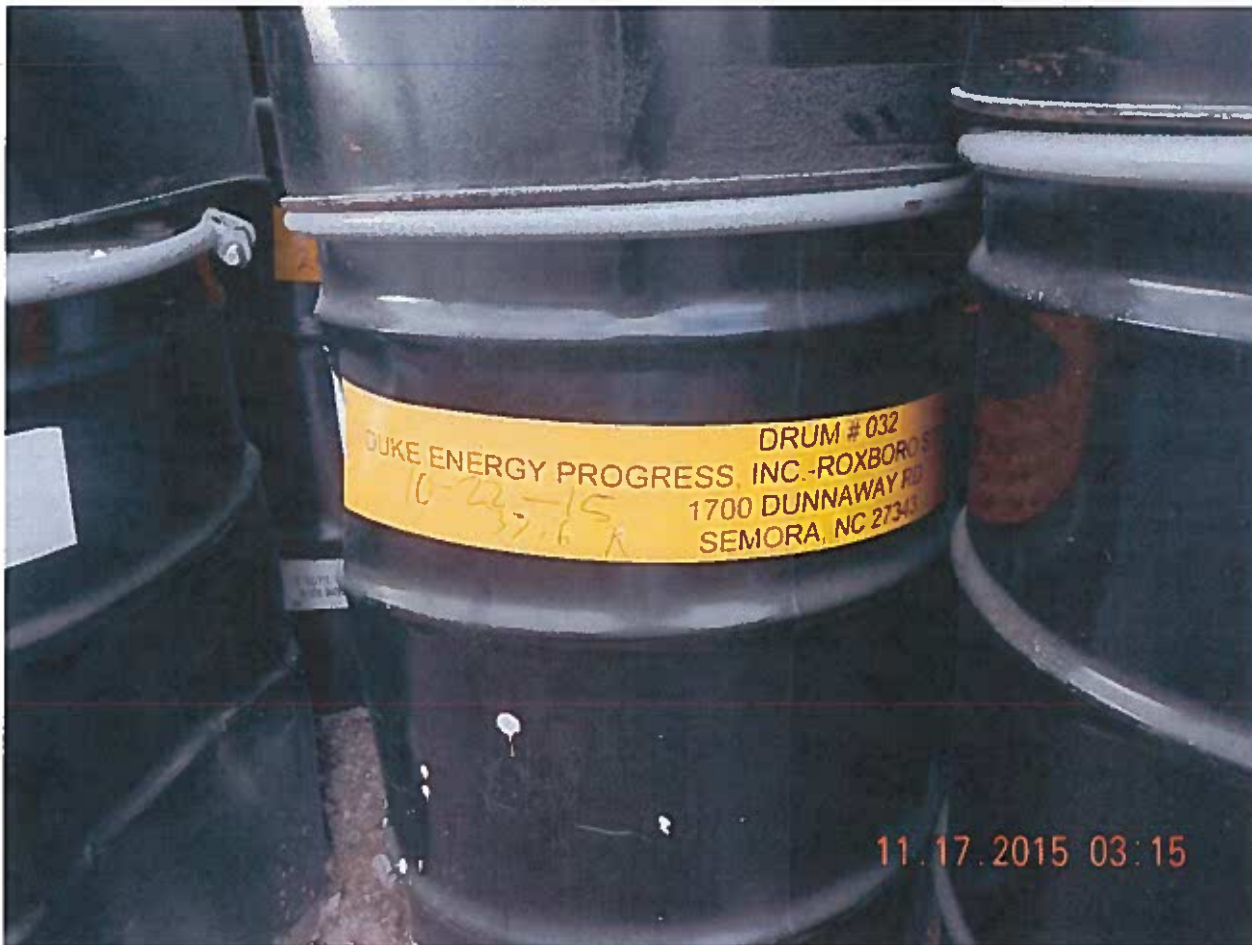
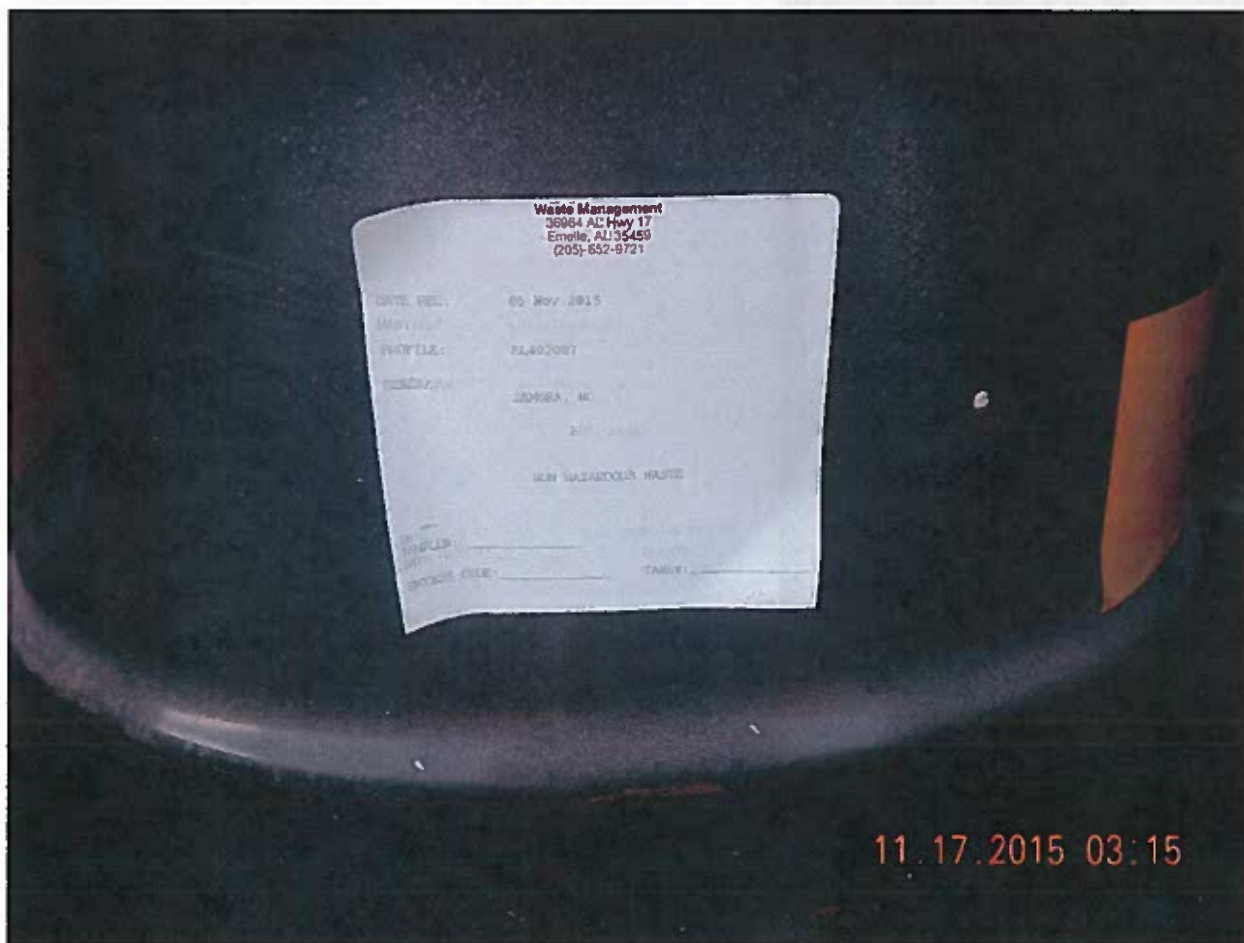
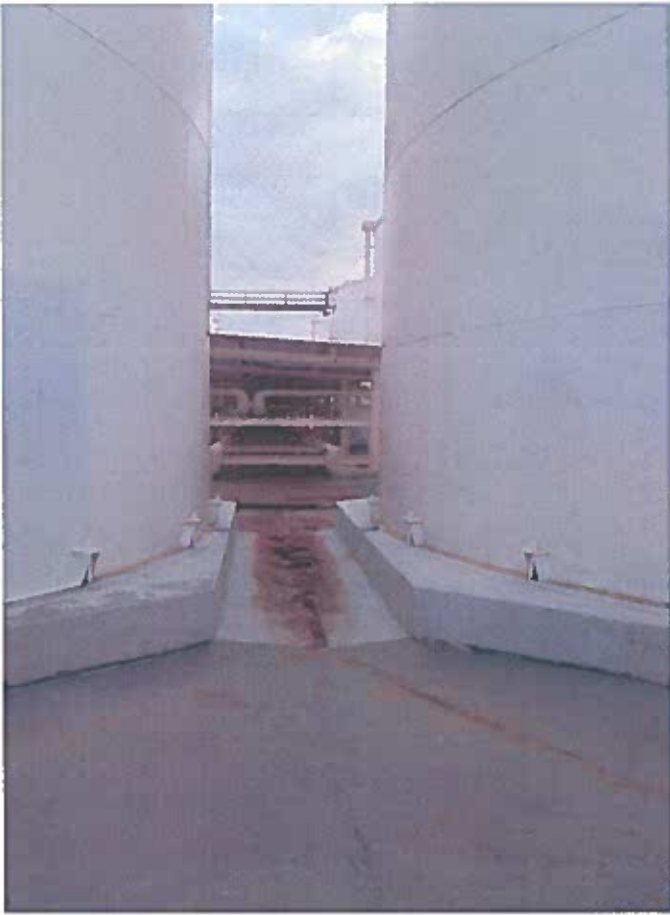
The inspectors also observed containers of non-hazardous waste, near the macroencapsulation vaults in Cell #4, including over one hundred (100) 55-gallon steel and plastic drums, a cardboard box, large machinery, and large containers similar to roll-offs (see Photos #8-12).

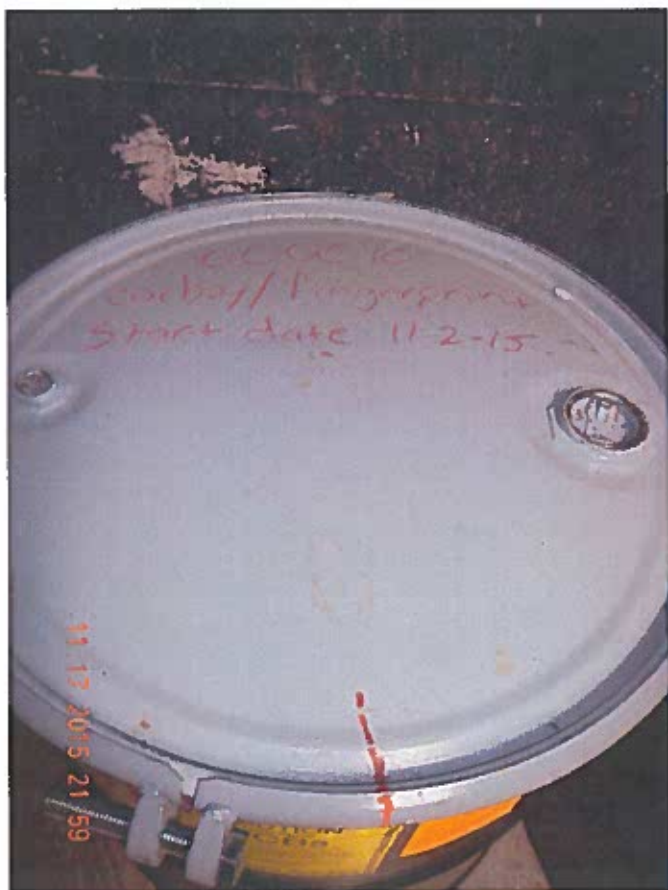
PHOTO #16

On the far end of the wet chemistry lab, behind a partial wall, the inspectors observed a satellite accumulation area containing two (2) 55-gallon drums stored side-by-side (see Photo #16). The drums contained sample waste generated by the lab that are then segregated into these containers based on the facility's designated treatment method for the waste stream type (incineration or stabilization). The current layout of this satellite accumulation area puts CWM Emelle accumulation limit of 55 gallons on hazardous waste.

Pursuant to ADEM Administrative Code R. 335-14-3-.03(5)(c)(1) [40 C.F.R. §262.34(c)(1)]. A generator may accumulate as much as 55 gallons of hazardous waste or one quart of acutely hazardous waste (...) in containers at or near any point of generation where the wastes initially accumulates, provided the generator complies with ADEM Admin. Code r. 335-14-3-.03(5)(c). CWM Emelle failed to ensure that the wet chemistry lab not accumulate hazardous waste in excess of 55 gallons, in a single, designated satellite accumulation area (SAA).

Per an electronically-available ADEM fact sheet regarding satellite accumulation of hazardous waste (see Attachment AF), ADEM "believes it is justified to allow satellite accumulation of up to 55 gallons (or one quart of acutely hazardous waste) for each distinct waste stream at or near its respective point of generation, even when the result is more than 55 gallons in total of different wastes being maintained in adjacent containers, so long as the various satellite accumulation containers are clearly separated and delineated to prevent mingling of the various waste streams." The placement of two fifty-five gallon waste containers, side-by-side, within a single satellite accumulation area does not appear to meet the ADEM exception/guidance outlined above.

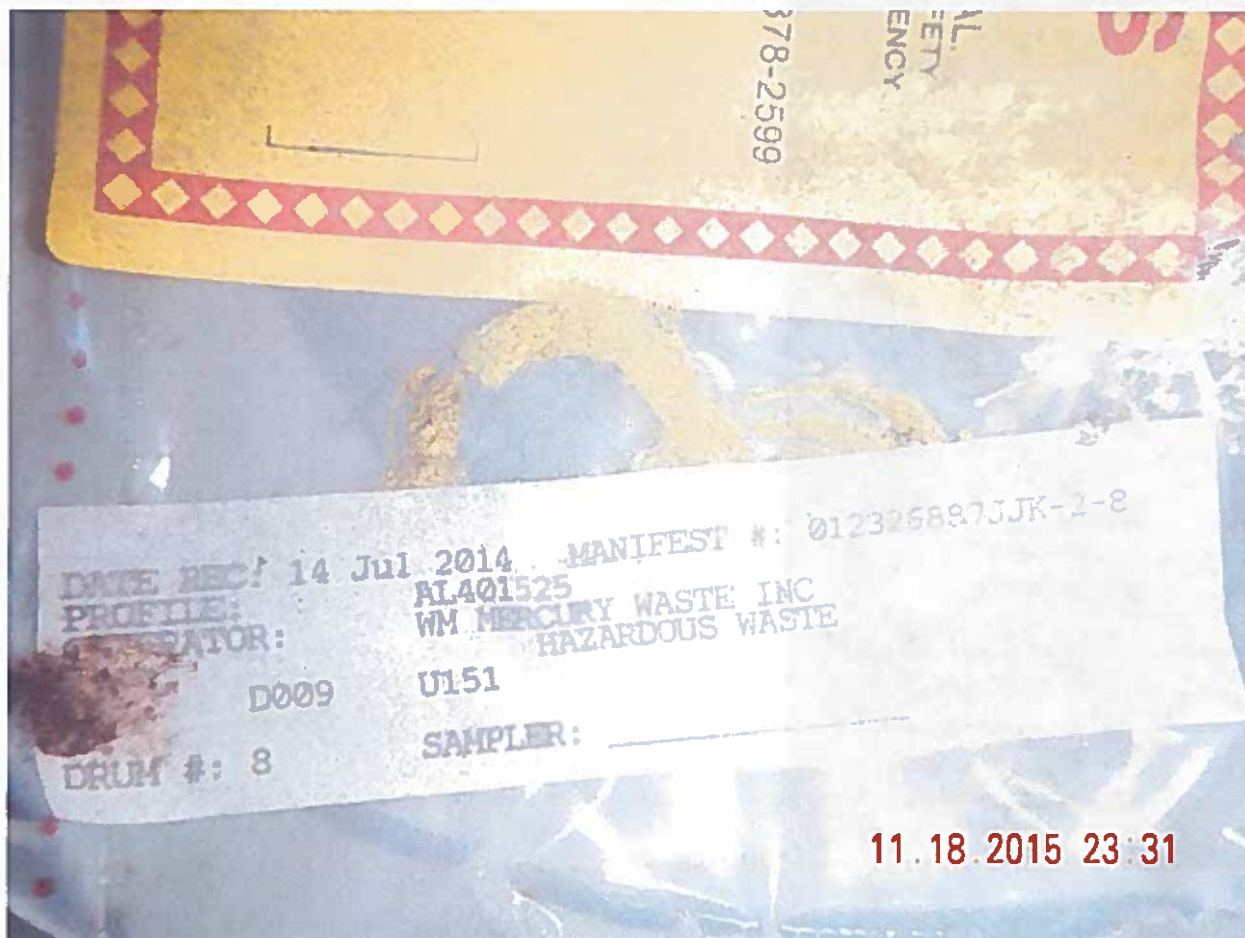
PHOTO #35

The inspectors noticed approximately sixteen (16) steel five-gallon buckets (see Photo #35) labeled as mercury hazardous waste with start accumulation dates beyond the one-year storage limit (see Photo #36). Mr. Coughlin explained that the facility is allowed to store this waste longer than one year until a suitable off-site facility is equipped to receive this specific waste. This information coincides with the Mercury Export Ban Act which allows elemental mercury to be stored for longer than one year at any RCRA-permitted TSD facility (meeting specific conditions).

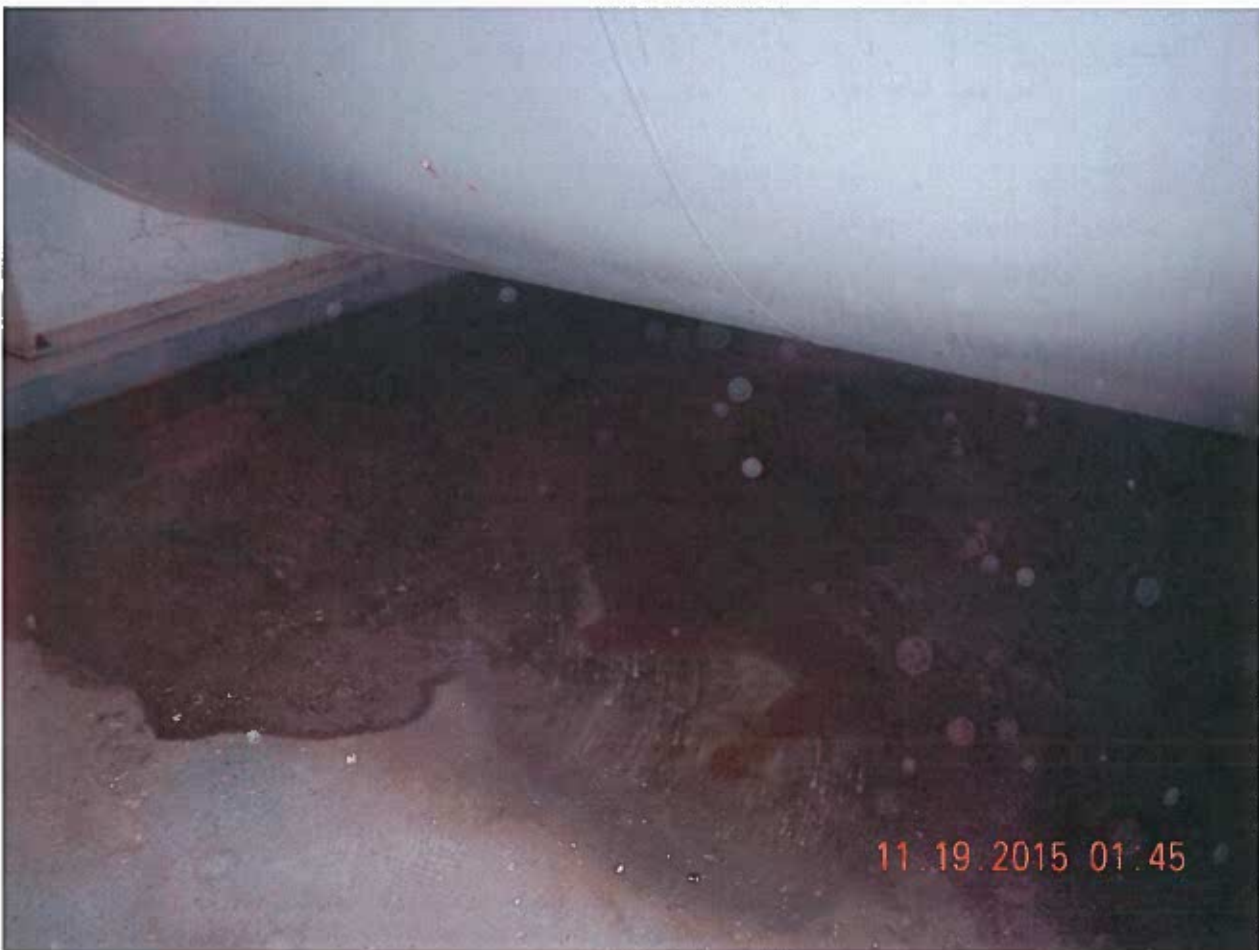
PHOTO #39

The inspectors also observed a significant volume of rainwater accumulated in the building's secondary containment (see Photo #39). The accumulated rainwater was likely collected during the wet weather event that occurred the day before.

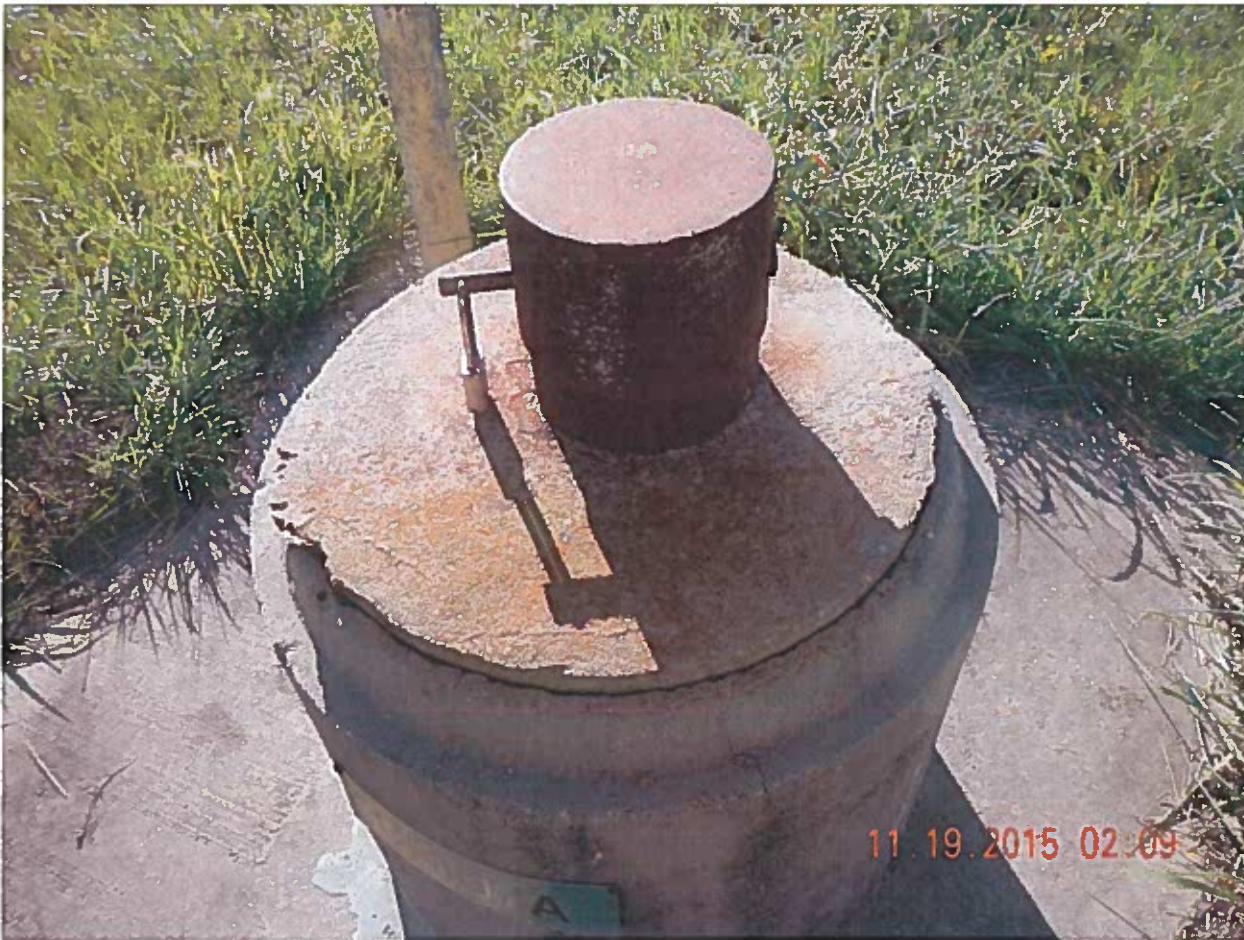
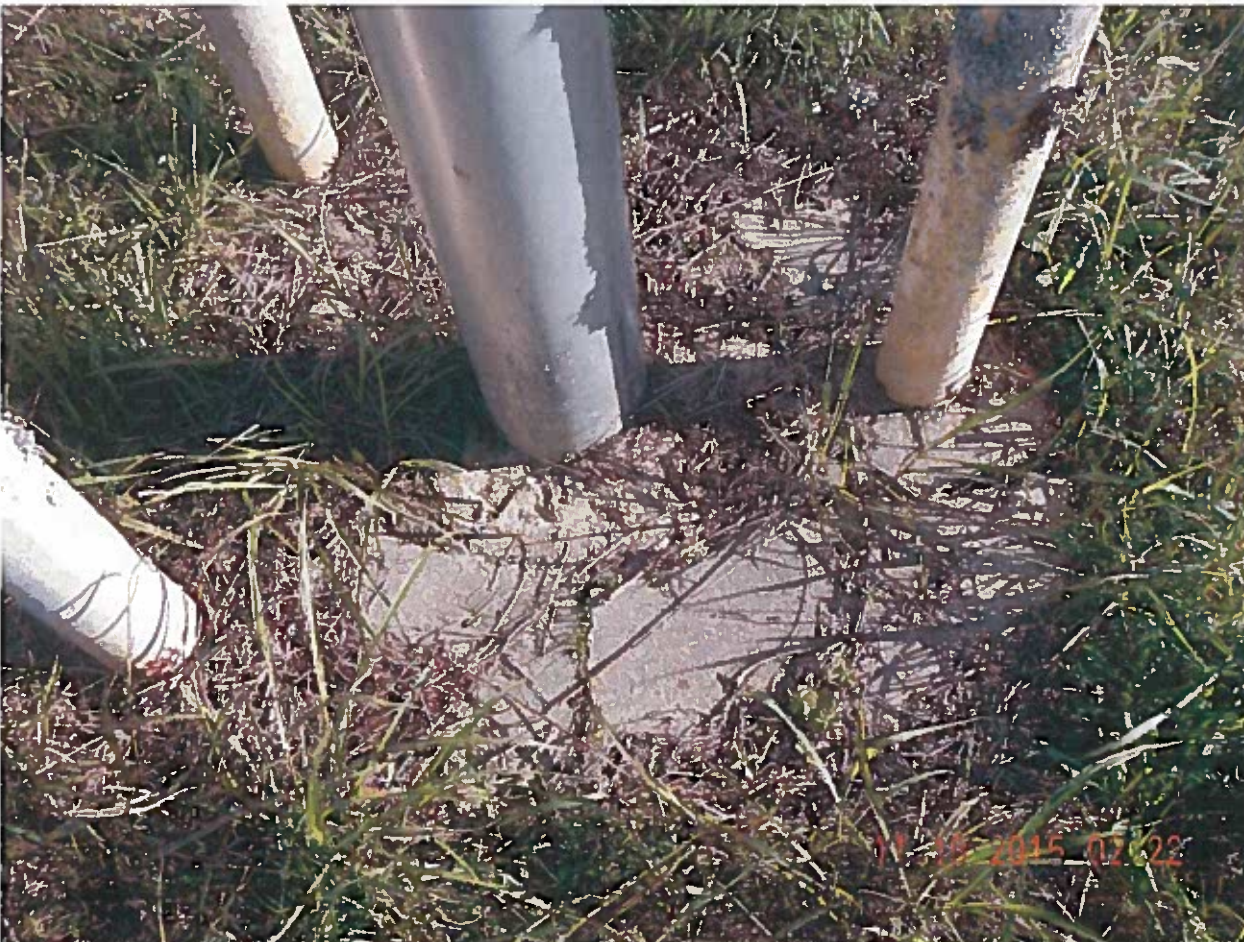
At trench 10, the concrete edge/casing around both SM-07 wells was missing (see Photos #42-43). At trench 16, the inspectors observed that the concrete base around PM17 was damaged (see Photos #44-45). At trench 9, the inspectors observed a black 55-gallon drum that was without a label (see Photo #46). Upon asking Mr. Dewayne Speight about the drum, he explained that the drum contained purge water used for sampling that had been conducted approximately a week prior to the inspection. Mr. Speight stated that the water was hazardous, although the facility later provided analysis documentation to demonstrate that the purge water was found to be non-hazardous (see Attachment U). At trench 8, risers were present but no wells were visible.

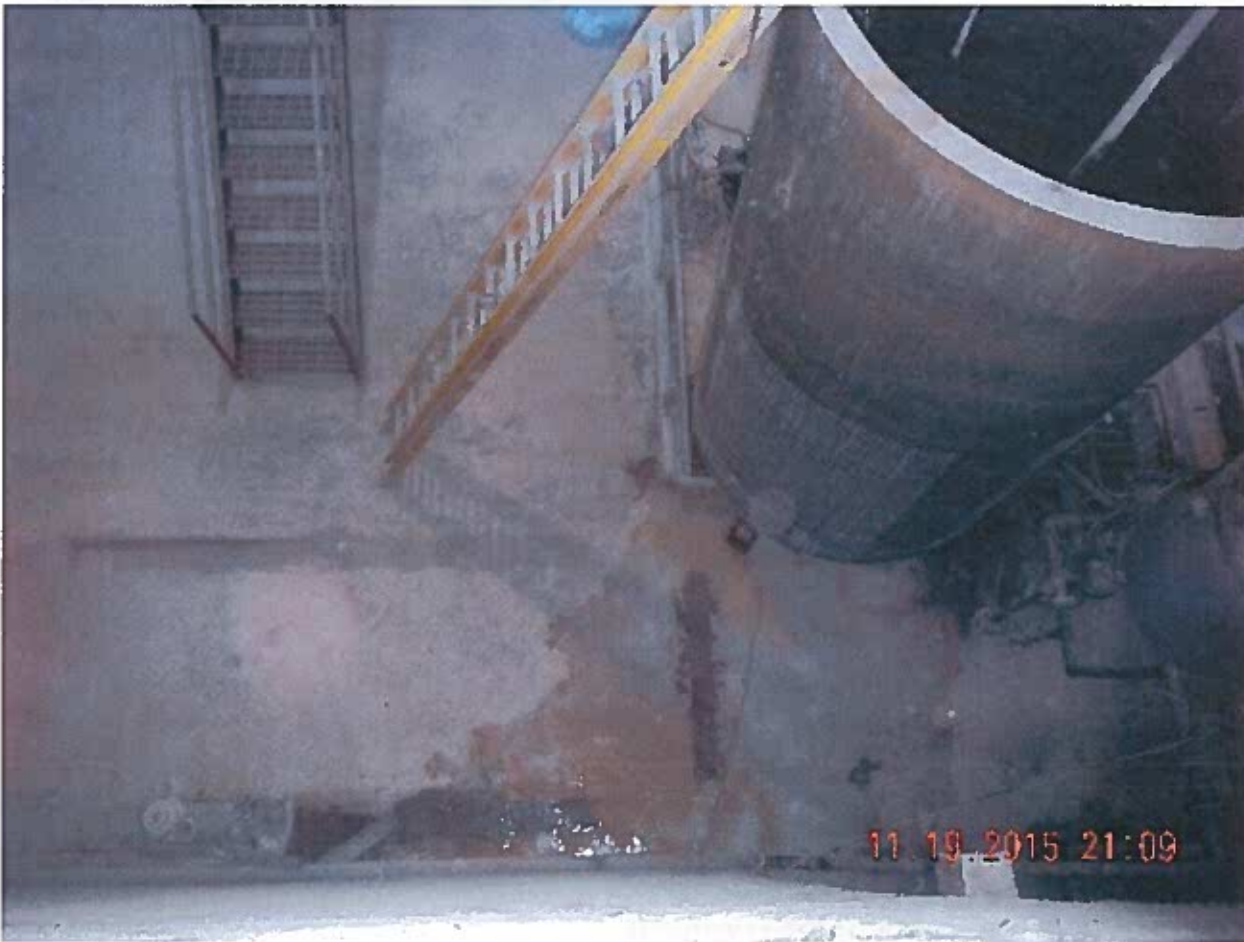
PHOTO #47

At the time of the inspection, Tank 902 was leaking due to a broken pressure switch (see Photo #47). Mr. Sturdivant explained that the wash water tanks are labeled as hazardous waste due to a past negotiation with ADEM, although analytical has shown that the wash water meets treatment standards. The sludge roll-off was labeled with a start accumulation date and covered with a tight-fitting tarp.

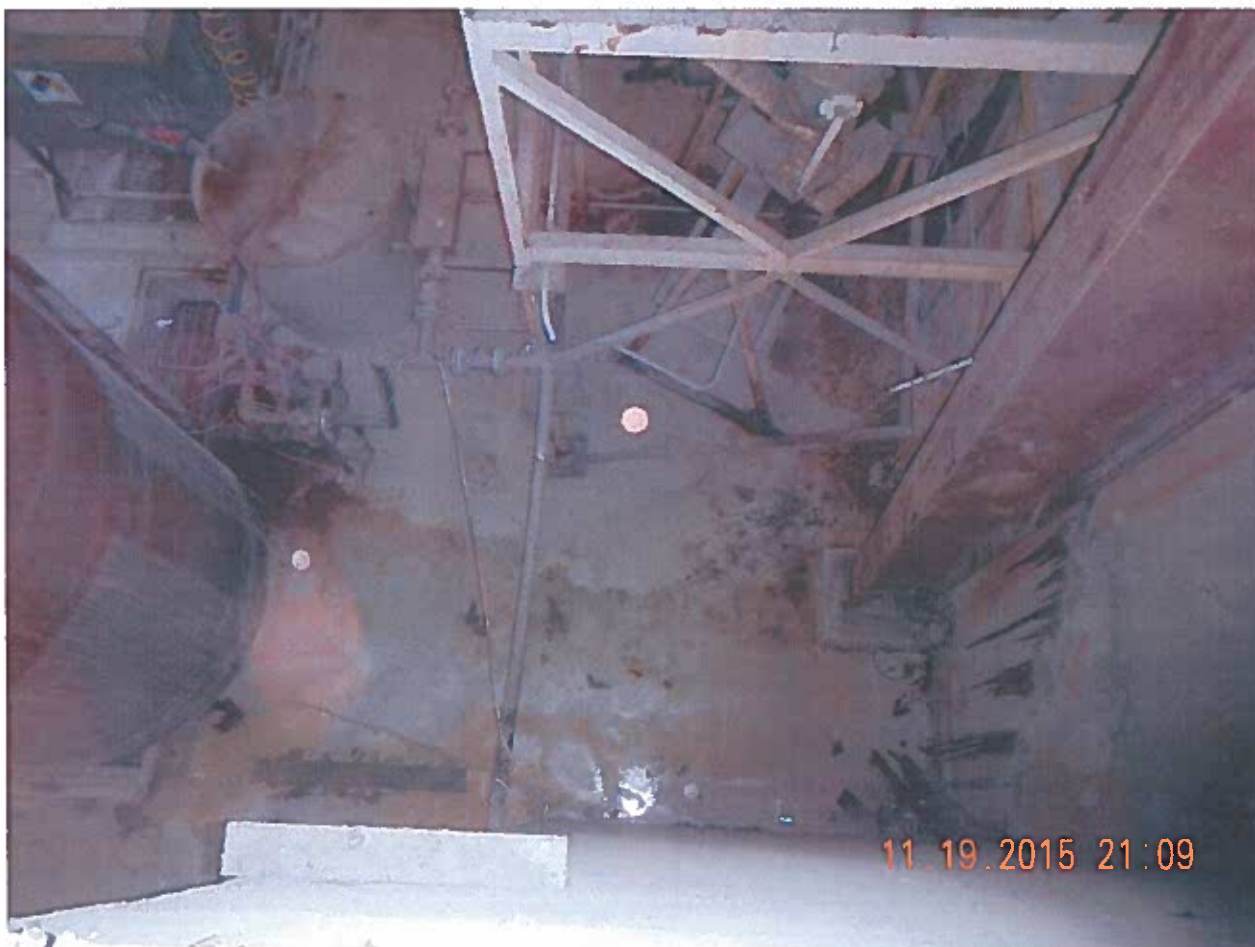
PHOTO #48

At the time of the inspection, the inspectors observed pools of liquid on the floor near the sludge tank (see Photo #48). After further examination, the inspectors also observed an obvious filtration into the building coming from a nearby wall (see Photo #49). Upon review of previous inspection reports from 2012 and 2014, this filtration is referenced in both reports. It is unclear whether this issue has ever been adequately addressed by the facility since it was first observed by inspectors. No remedial work order for this building was observed during the records review portion of the inspection.
